## Environmental Management Services

### **Interceptor Suitability Assessment & Install - Case Study**

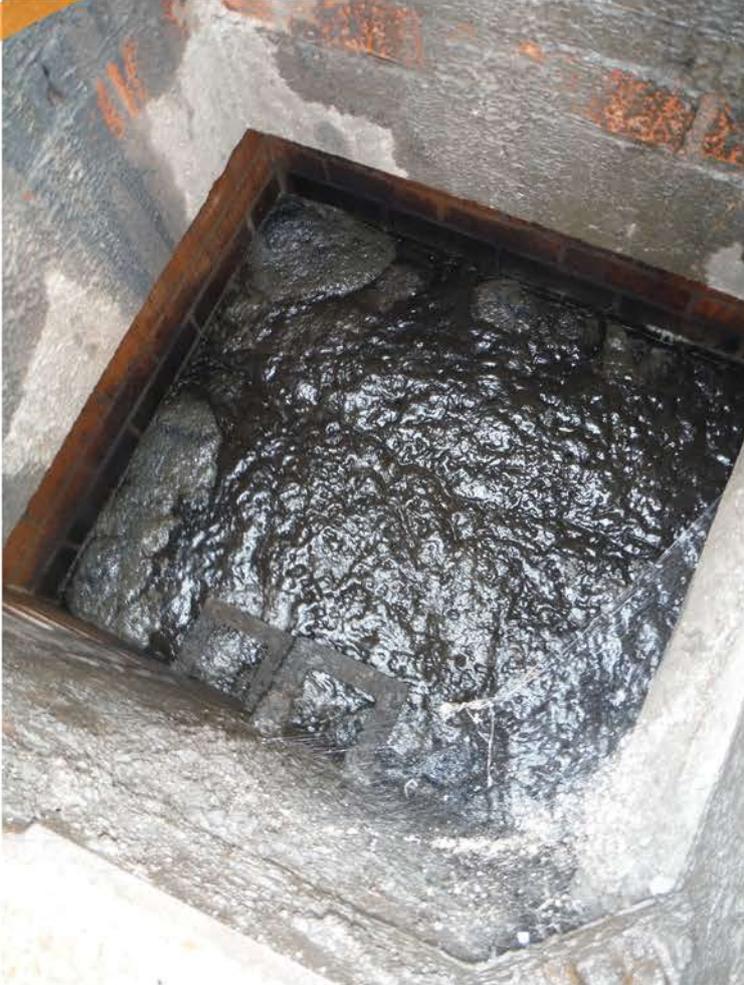
On inspecting the interceptor it was found to be a single-chamber, of un-lined engineering brick construction.

There was very little liquid present, owing to large amounts of suspended solids and silt accumulated in the chamber.

This lack of liquid could have been accounted for by displacement of the water by the high volume of solids but it could also indicate that the system's structural integrity had been compromised and that the chamber was allowing liquid to escape to ground.

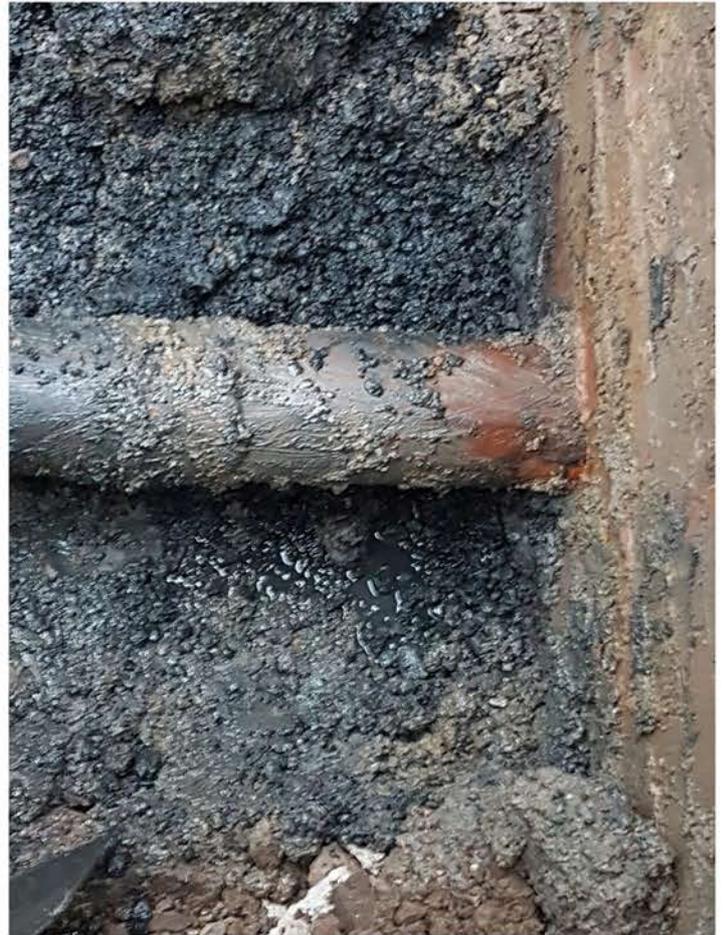
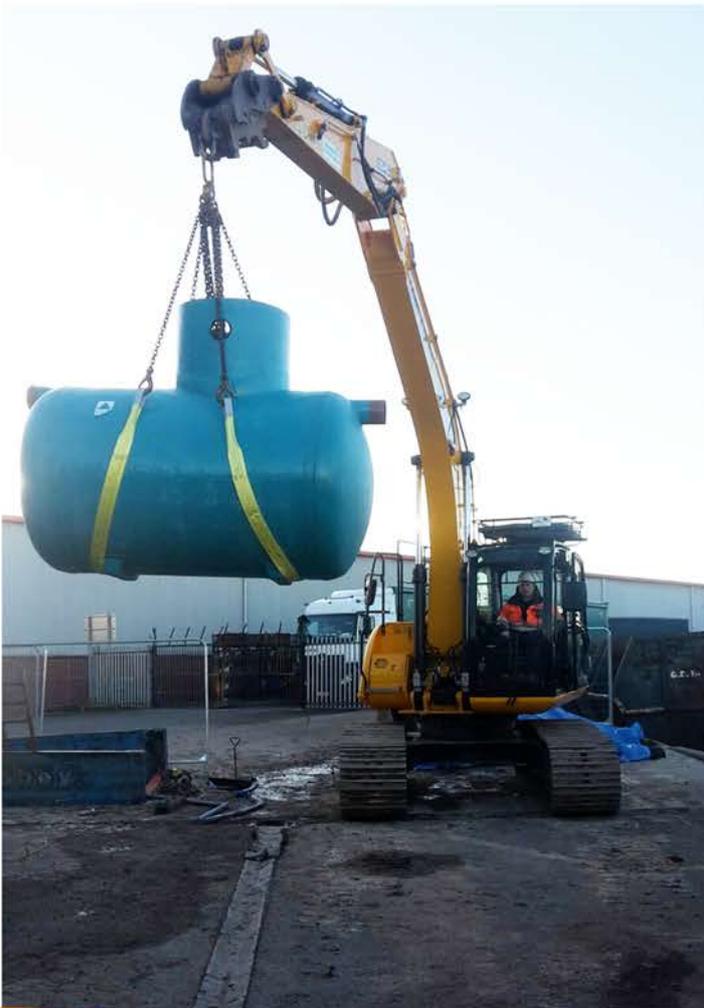
During the excavation for the new interceptor oil contamination was discovered within the ground. This confirmed that the existing interceptor's integrity had been impaired, allowing contaminants to leach out into the surrounding soil and groundwater.

The contaminated soils were removed, stockpiled and sampled to ascertain the level of contamination. This allowed for proper waste classification and ensured the contaminated soil was disposed of in compliance with all regulations and in the most cost effective manner.

The Class 1 interceptor was installed downstream of the newly modified solid drop out chamber prior to the discharge to the foul drainage system.
