Environmental
Management
Services

Interceptor Service & Repair Case Study

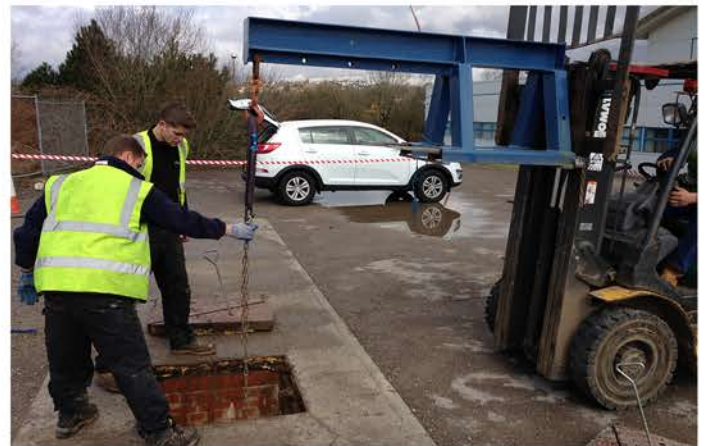
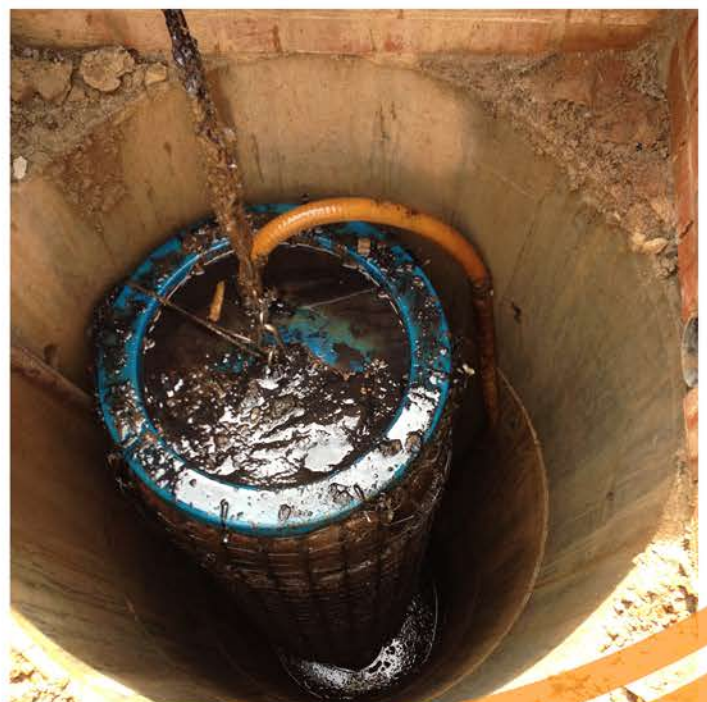
During the audit we used a forklift to carefully remove the coalescers and inspected them on the surface. We found that of the 5 coalescers 1 had become unattached and was sunk in the chamber; the remaining 4 were heavily saturated in oil and all 5 needed removal and refurbishing.

The faulty coalescers were jet-washed to remove as much of the contaminants in the filter media as possible and the resulting oil water mix was tankered away. The coalescers, Oregon hose and oil skimmer were safely removed.

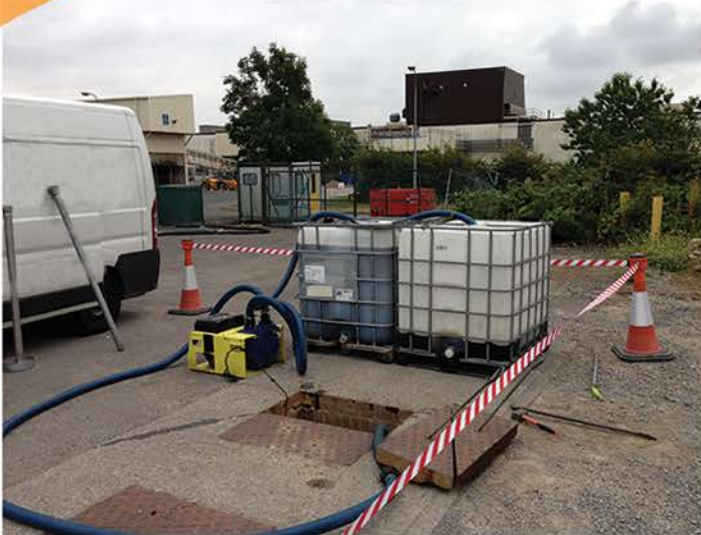
Once the tanker had emptied as much as possible from the surface a confined space entry team entered the interceptor with full breathing apparatus where they jet-washed the walls and checked the chambers structural integrity.

The internal structure of the interceptor was found to have multiple breaks. As well as the structural issues the interceptor's Oregon hose was found to be faulty and the oil skimmer was not functioning.
