**Environmental  
Management  
Services**

## **COMAH Bund Survey and Construction Case Study**

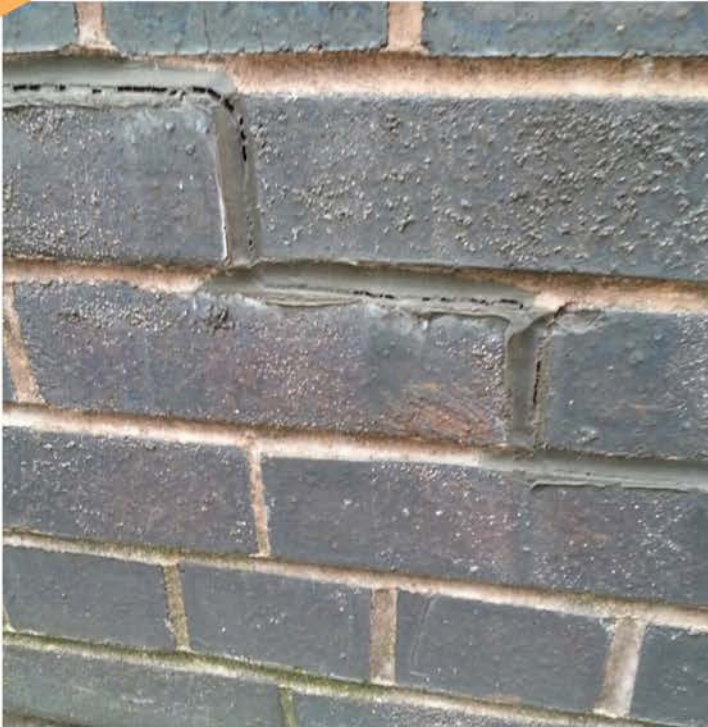
Following a scheduled audit by a COMAH inspector our client was advised that their bunds were in breach of CIRIA C736 standards. Our Environmental Consultants conducted a survey of the bund and found several non-conformities; there were fractures throughout the concrete bund floor and the walls were constructed from double-skin engineering brick, which under the COMAH regulations is unsuitable and unfit for purpose.

We also found evidence of the concrete being corroded on the wall-floor joint by the caustic soda being stored within the bund. It was also established that the wall had been subjected to vehicle impact and superficially repaired with silicon mastic sealant. The wall was therefore no longer able to withstand the level of internal pressure which it had been originally designed to.
