**Environmental
Management
Services**

Interceptor Repair Case Study

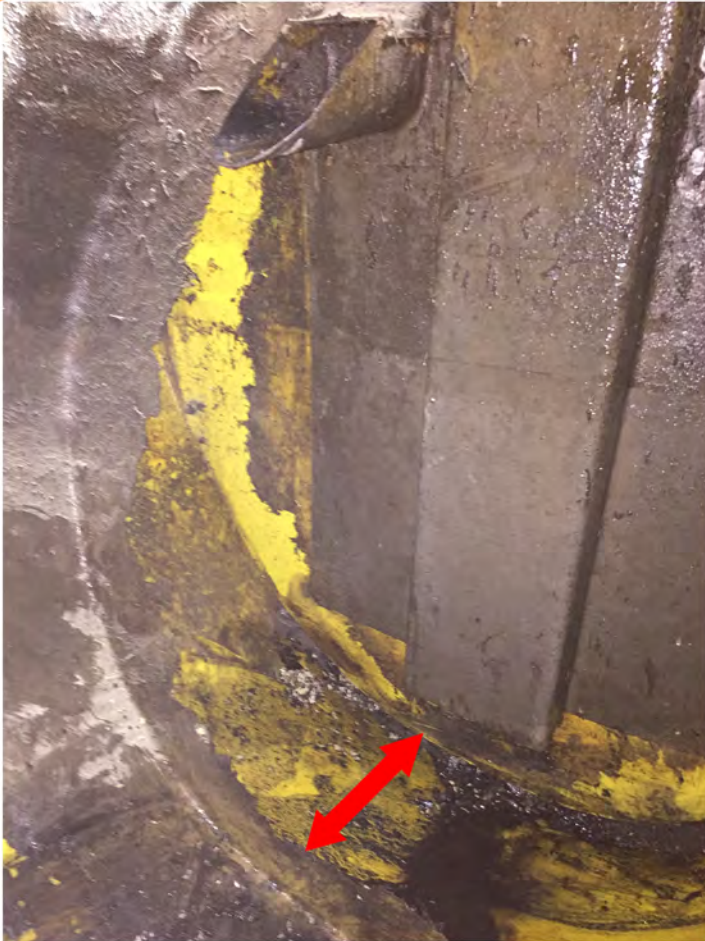
During an interceptor integrity inspection we found that the baffle wall on a GRP interceptor had become delaminated. This had caused the wall to become much weaker which had resulted in it partially dislodging and shifting by approximately 50cm, preventing it from functioning effectively.

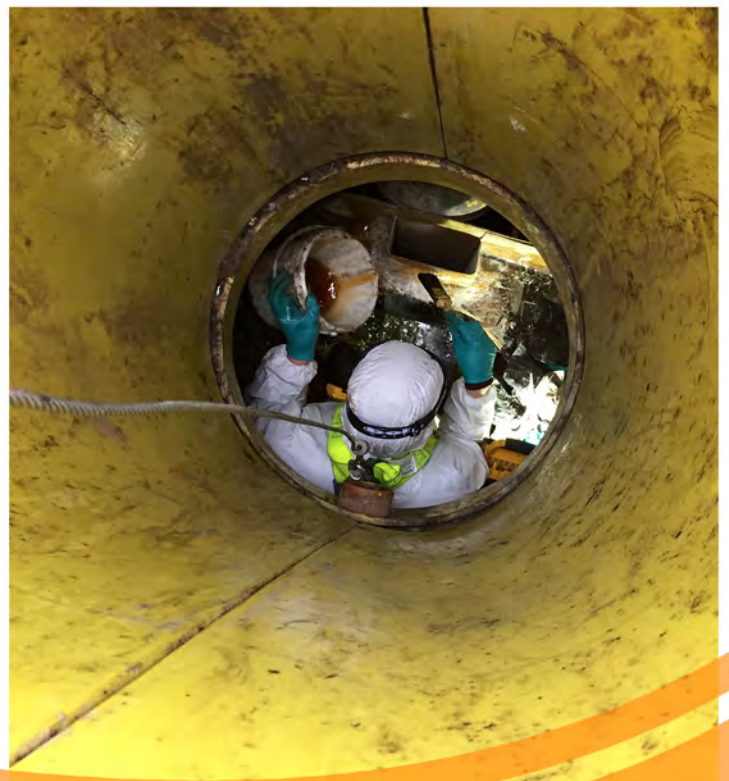
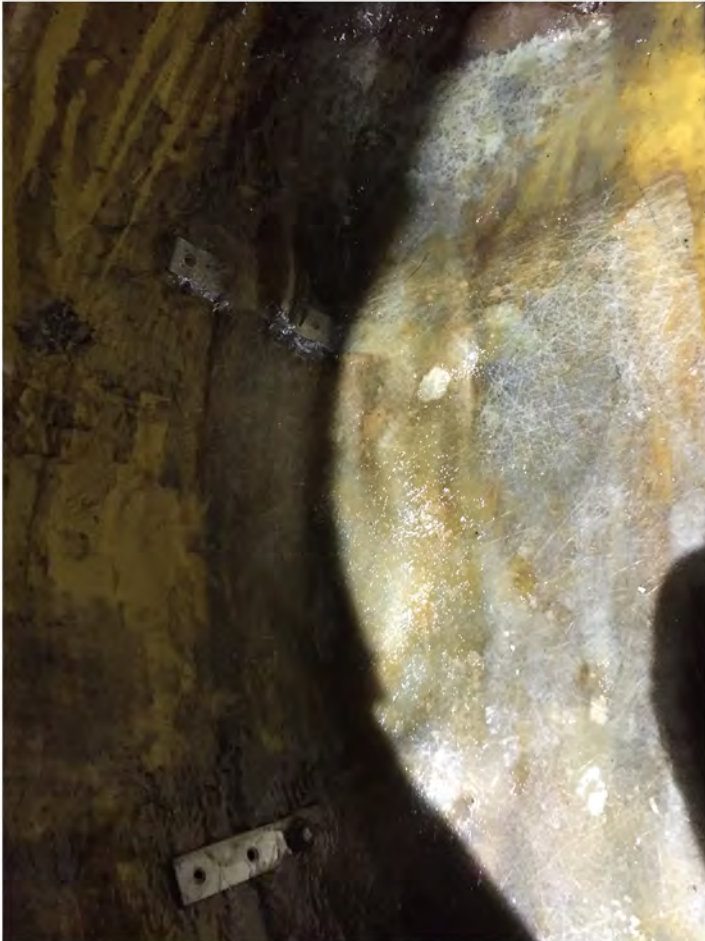
As the access shaft was too small to allow entry into the system the inner secondary sleeve was cut away to create a suitably enlarged access to carry out the works. Our confined space entry team were then able to enter the interceptor in order to complete the repairs.

The failed baffle wall was then manipulated back into its correct position and fixed in place by steel L brackets and self-tapping screws.

The interceptor surfaces immediately surrounding the failed baffle wall were abraded and all loose debris removed to leave a suitable area to attach the GRP patch repairs.

The chopped glass fibre strand matting was then cut to size and applied to the failures and over the L brackets and sealed in place with polyester resin and styrene monomer. This was to ensure the baffle wall was impermeable to chamber contents and that any failure points to ground created by the screws were sealed simultaneously.
