Environmental
Management
Services

Hydraulic Oil Spill Response

Initial Incident & Response

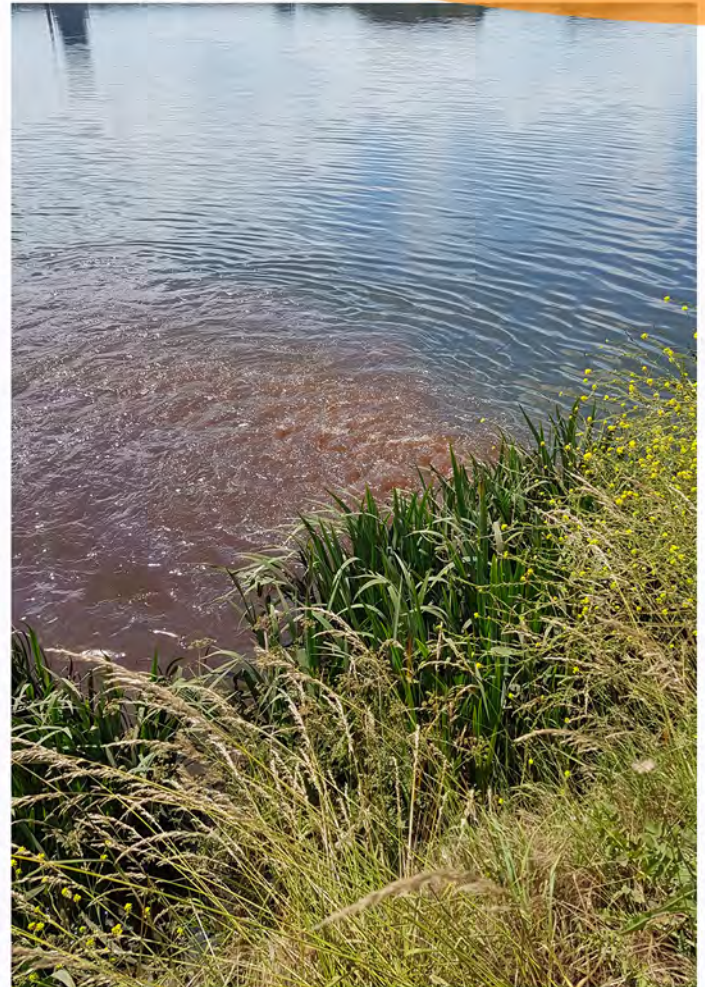
When our team arrived on site the delivery vehicle had been isolated to ensure no further oil was lost; however there was still a large amount of oil entering the lake through the drainage system.

Our response team blocked the outlet from the drain, preventing any further oil escaping into lake and utilising the drainage line as tertiary containment.

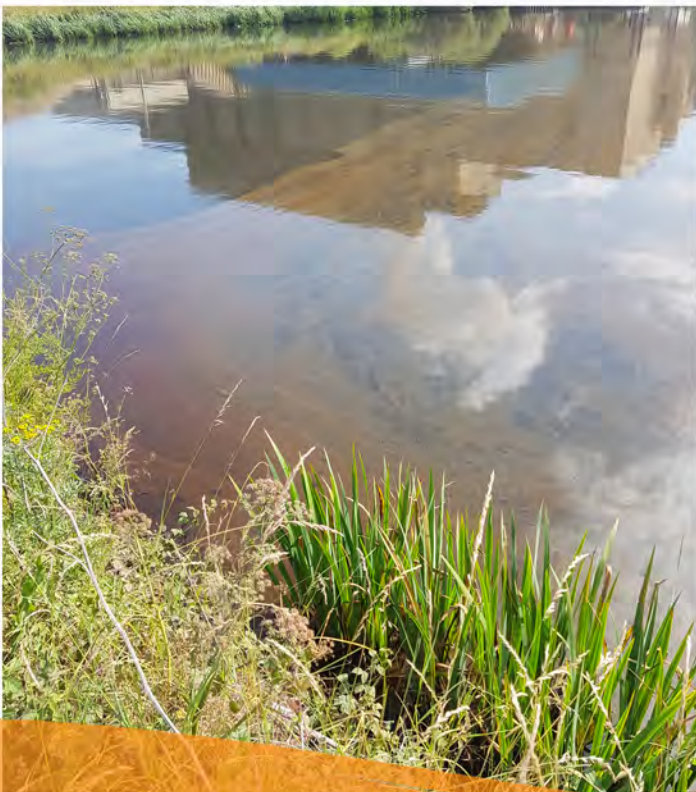
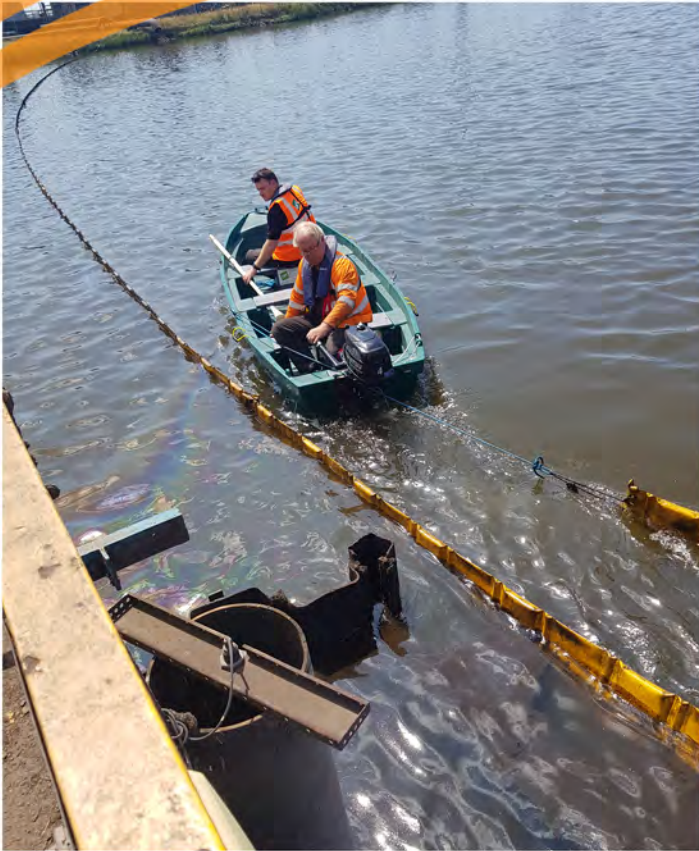
Large quantities of oil were visible on the water surface and due to flow and wind direction had begun gathering next to the bank at the opposite end of the lake.

An emergency vacuum tanker attended site, emptying the contents of the drain and cleaning it to remove as much residue as possible, before collecting the wash water.

A fence boom was installed around the outlet of the drain and the drain line was reopened. The fence boom was put in place as a precaution to collect any remaining residues from the drainage, although the vast majority had already been removed.

By this stage all visible contamination had now settled against the far bank, we fitted a fence boom around the area to keep the oil contained to a small area.

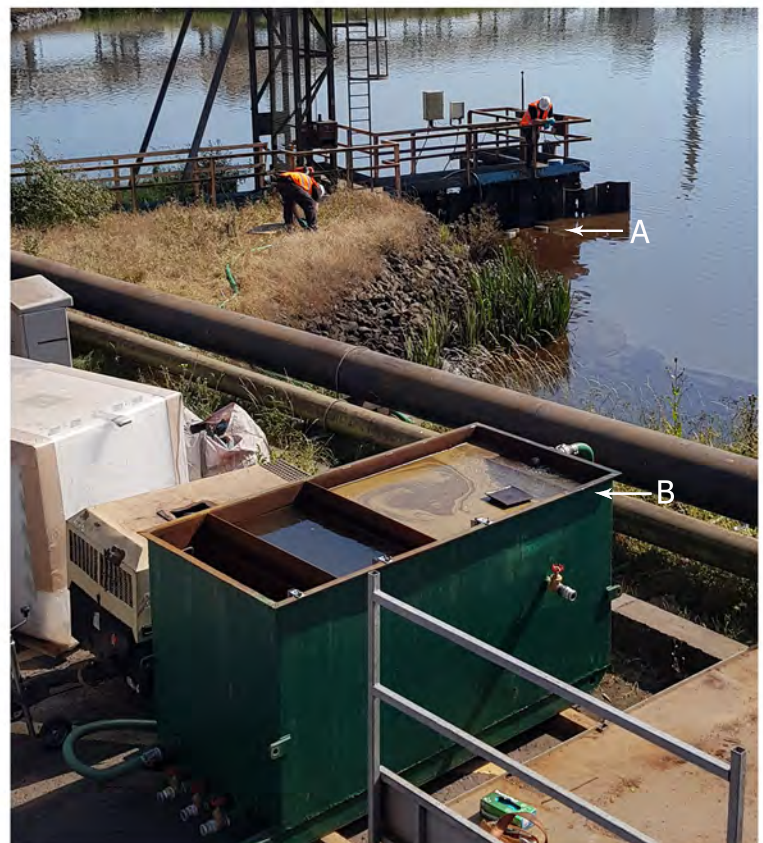
A weir skimmer ("A" in below photo) and mobile Oil Water Separator OWS ("B" in below photo) were installed to recover the amassed oil.

This proved extremely effective and was regularly emptied by a tanker to remove and dispose of the recovered oil, this was left in place for 10 days, and in all the skimmer and OWS removed approximately 18,000 litres of oil.
