Environmental
Management
Services

Bund Cable Entry Sealing Case Study

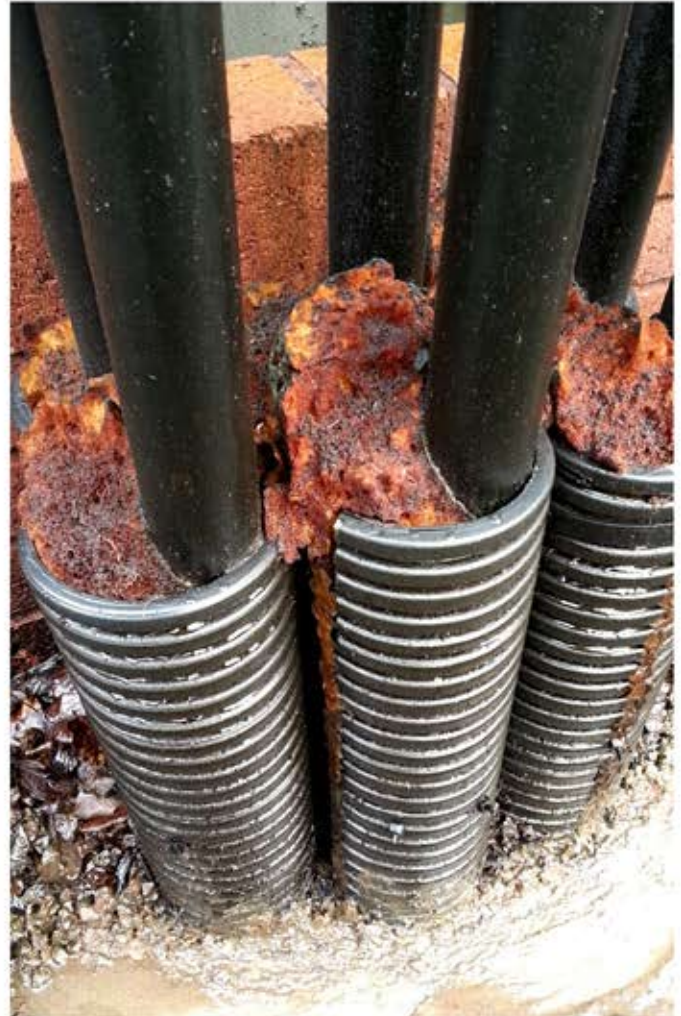
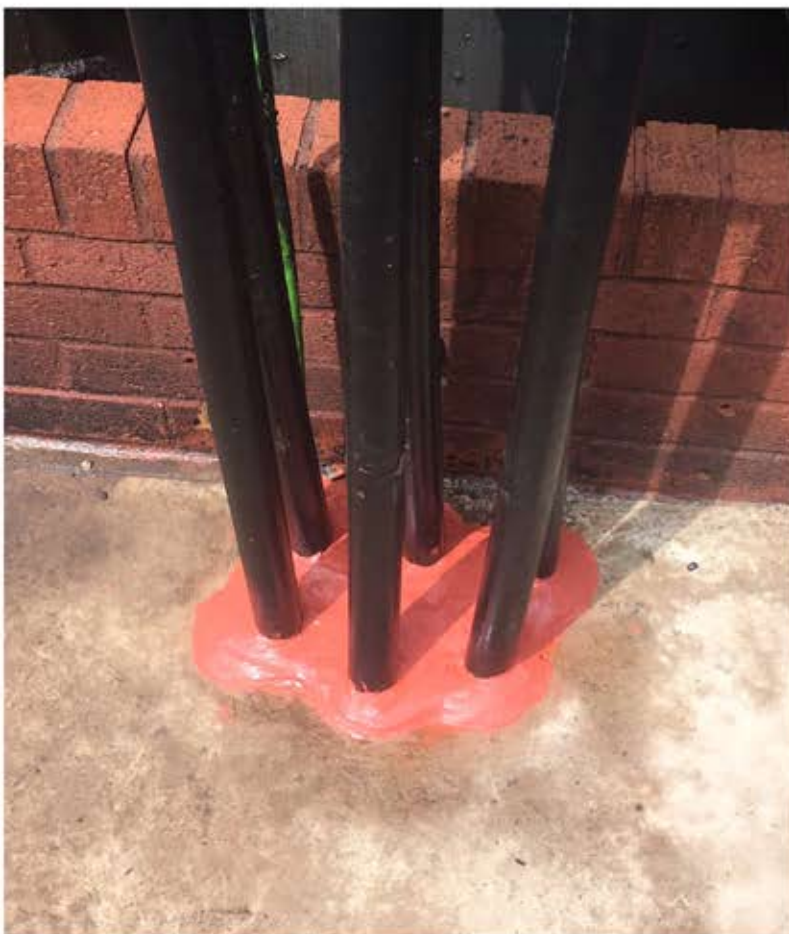
During an environmental audit of a major DNOs substation we found that the cable entries into their transformer bunds had not been effectively sealed. The cable entries had a split duct running through them which had been filled with expanding foam.

The foam seals were not watertight and this was allowing oil to migrate through the cable entry and providing a path for the oil to escape to ground, in breach of the Oil Storage Regulations which state that where there is a penetration into the bund walls or floor:

“the junction of the pipe with the base or walls must be adequately sealed to prevent oil escaping from the system.”

We undertook a programme where we would remove the ducting to below ground level, remove the expanding foam and clean the cables, prepare the duct and fill with CSD RISE a specialist sealant leaving the bund watertight and preventing the loss of any oil to ground.
