**Environmental  
Management  
Services**

## **Separator Compliance Assessments Case Studies**

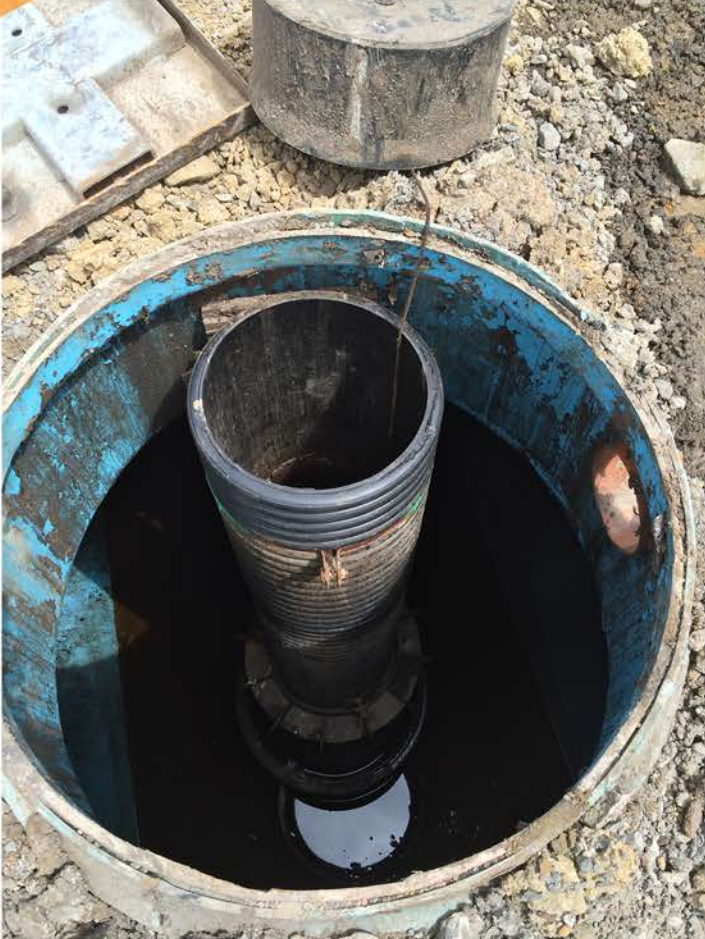
## Case Study 1

We found that the interceptor was a sufficient size and suitable class of interceptor for the future usage of the site.

There was some damage to the coalescer which meant the interceptor was not fully functioning, however we were able to repair this defect during the service to return the interceptor back to a fully functional system.

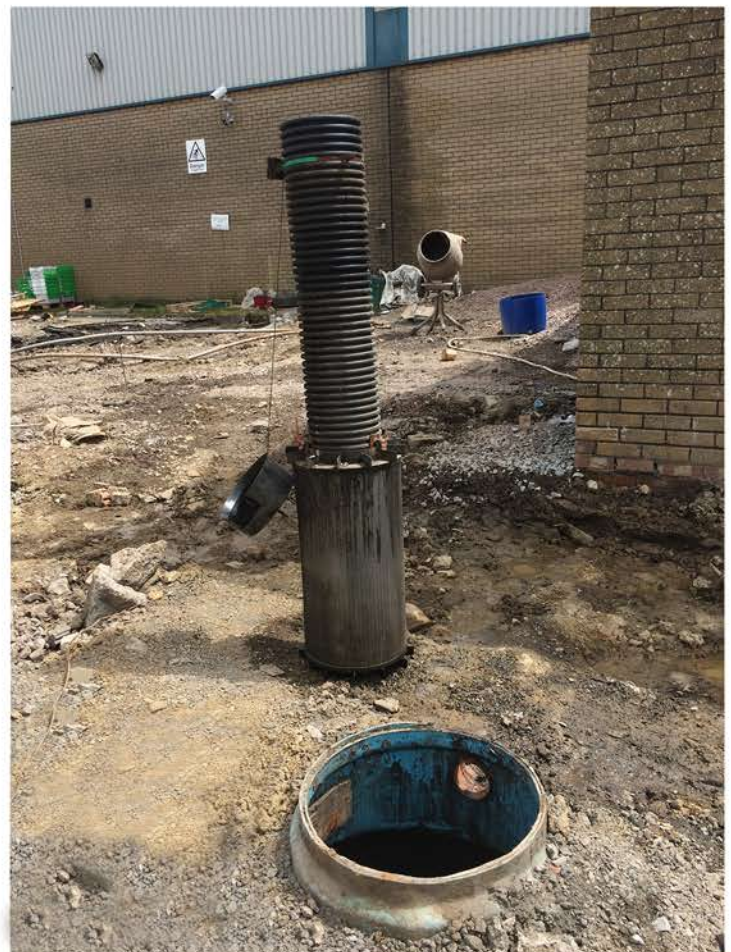
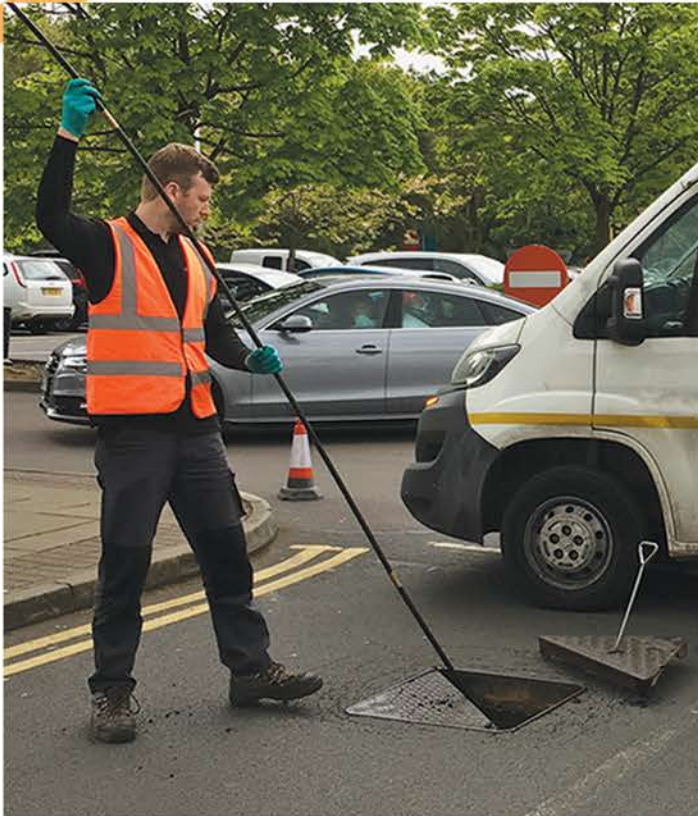
## Case Study 2

Our client was in the process of converting a site into a car dealership and wanted to know if the current interceptors were suitable and fully functioning. On inspecting the interceptors it was found that they were fully functioning however the interceptors installed were not fit for purpose.

The interceptors were Class 2 and installed in the surface water system, surface water interceptors must be Class 1. The interceptors were also too small for the catchment area they were servicing.

If the interceptors were specified correctly when they were initially installed they would still have been fit for purpose, however they needed to be removed and replaced with larger class 1 systems.

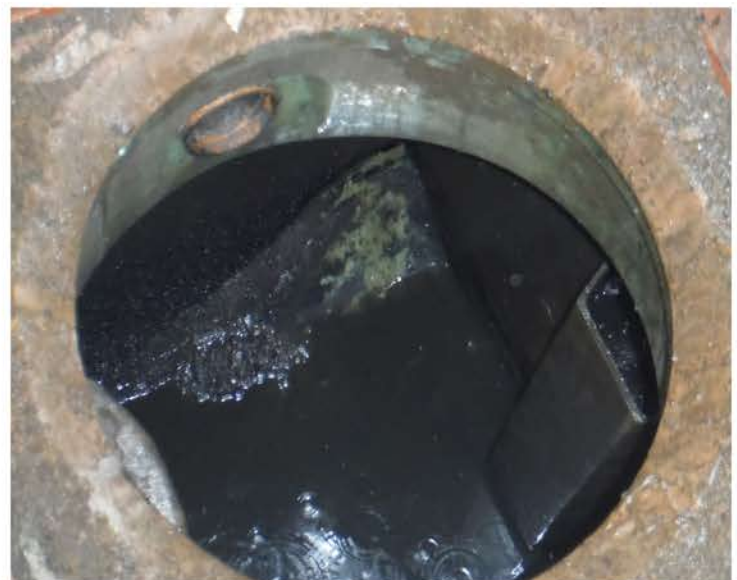
## Case Study 3

During an ISO 14001 audit it was flagged up that the interceptors on site were not being maintained. We were asked to inspect the interceptors to ensure that they were fully functioning and fit for purpose.

Although the interceptors were fit for purpose when they were installed a lack of maintenance meant they had developed irreparable issues.

The client were provided a report recommending the interceptors were removed and replaced, a proper maintenance regime would have cost a fraction of the cost of removing and replacing the interceptors.
