**Environmental
Management
Services**

CCTV Drain Survey & Drain Repair Case Study

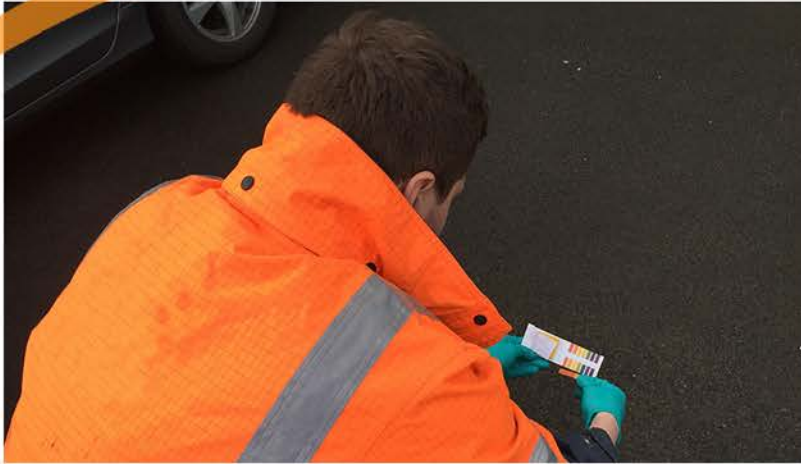
Our client contacted us shortly after the installation of a drain closure device activated by pH sensors. The drain closure device was regularly activating despite any identifiable incidents on site. We conducted pH tests at various points on site to narrow down the location at which the chemicals were entering the drainage.

Once we had narrowed down the location of the chemical ingress we conducted a CCTV drain survey on the suspected damaged drain line to identify damaged pipework. The CCTV survey identified several potential sources of contaminant ingress through damaged pipework.
