**Environmental
Management
Services**

COMAH Bund Survey and Construction Case Study

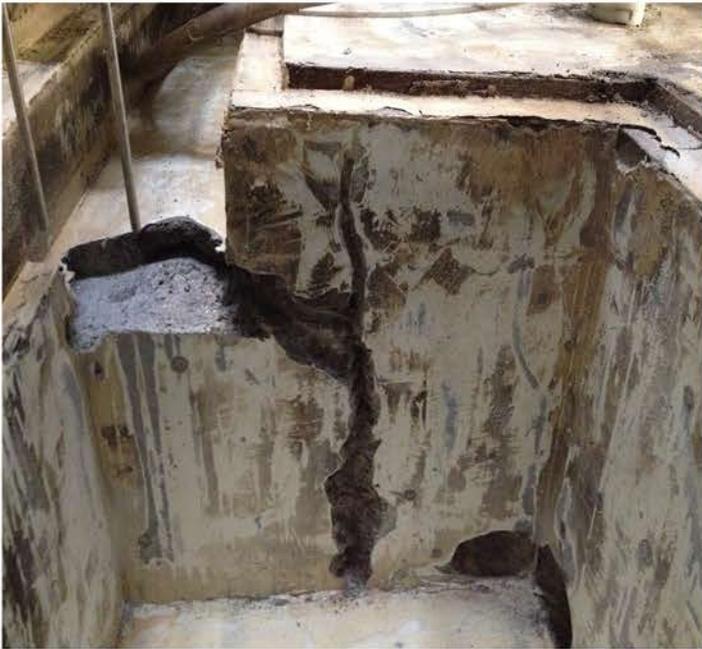
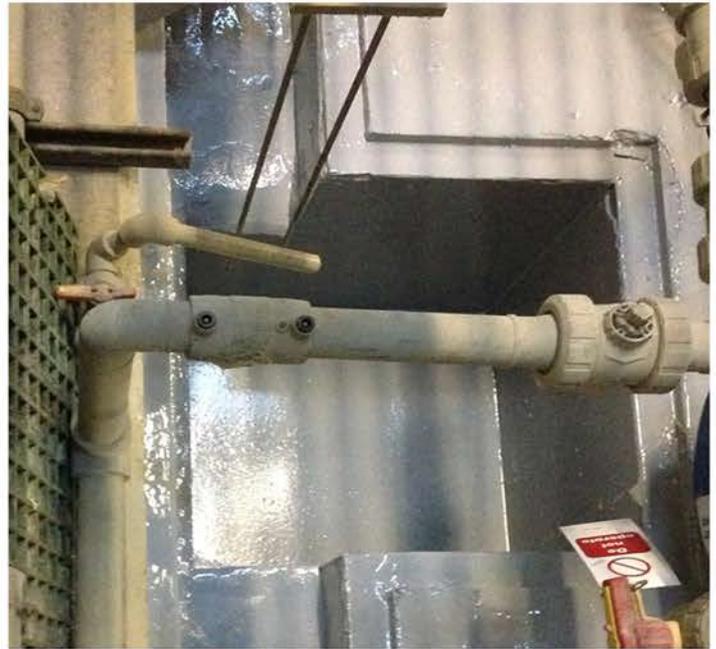
We were asked to repair and reline a 180 m² bund in the COMAH area of one of the largest manufacturing plants in the UK. The bund was housed underneath the production plant to capture any acid leaking from the tanks above. Due to the bund not having a sufficient chemical resistant lining the acid had attacked the concrete structure of the bund. Due to the sump being constantly submerged in acid there was significant corrosion present.
