Environmental
Management
Services

Substation Cable Duct Sealing ROXTEC

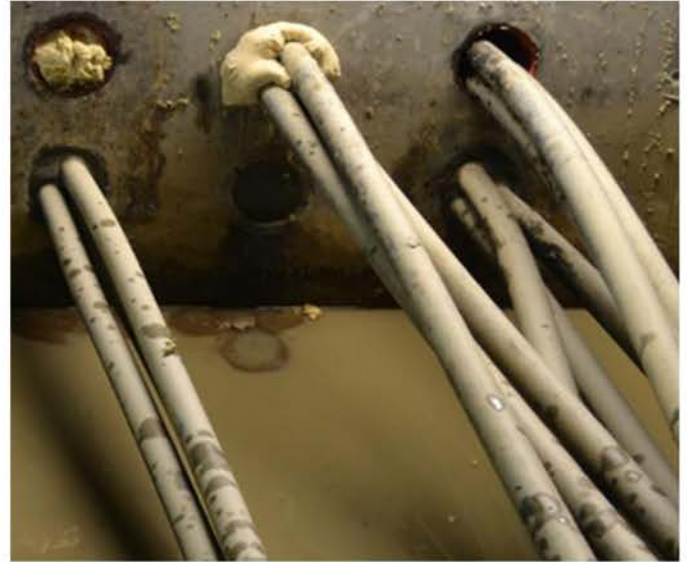
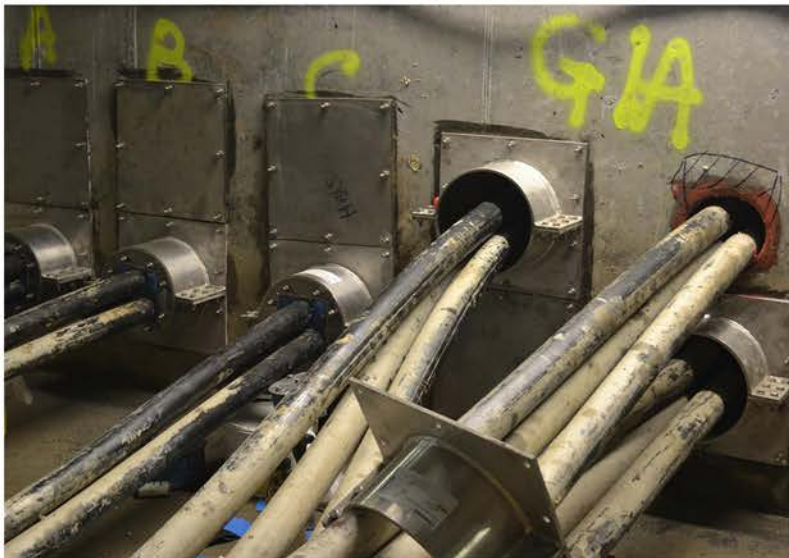
During a site survey the condition of the ducts was assessed. The ducts were of poor construction and so could not have a ROXTEC seal installed inside them. This meant that all of the ducts had to be sealed using specialist capping plates with a duct built in. All of the ducts and cables were measured so that the specialist plates could be tailor made to ensure a perfect seal. Once the plates had been manufactured the ducts and cables were cleaned and the plates were installed, immediately stopping any further water ingress.

The ducts were poorly constructed meaning specialist capping plates and seals needed to be manufactured. The plates were installed in flowing water conditions and immediately prevented any further water ingress.
