## Environmental Management Services

### **Flood Defence Cable Entry Sealing - Case Study**

We were commissioned by a major electricity distribution company to undertake retrofit cable entry sealing as part of a flood defence project for a 1 in 1,000 year flood event.

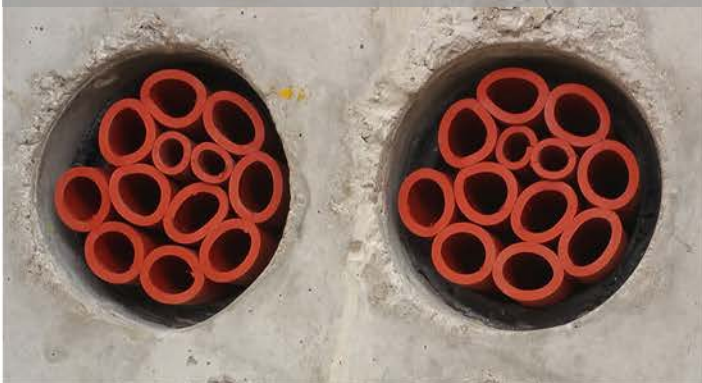
Packers inserted into ducts

The approach adopted consists of organising and lifting the cables into split rigiducts, constructing a reinforced wall around the ducts which is sealed with a waterproof render to prevent any water ingress around the ducts. The split ducts are organised internally using specialist packers and then sealed with the CSD RISE mastic sealant.

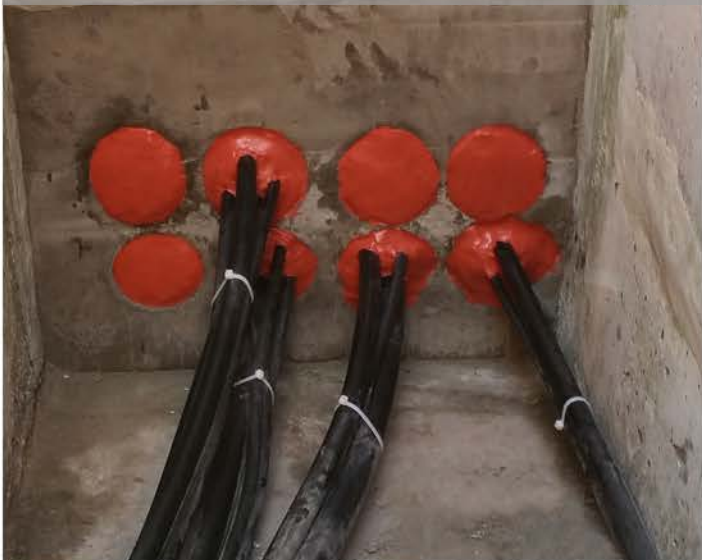
Ducts effectively sealed

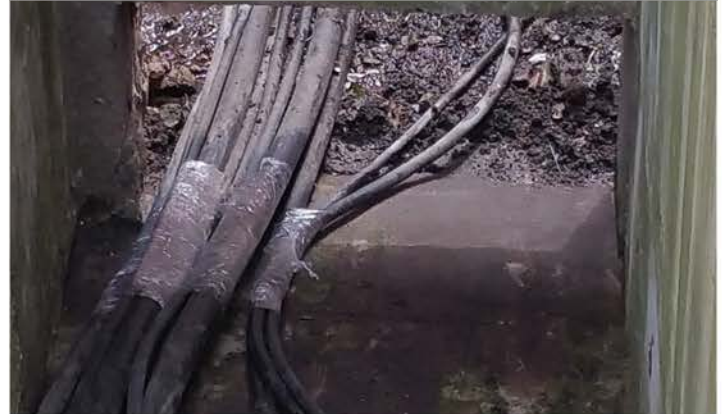
Cables organised and void cleaned

To allow the effective installation of the seals specialist civil alterations had to be conducted where the cables entered the assets through large voids as opposed to plastic rigiducts.

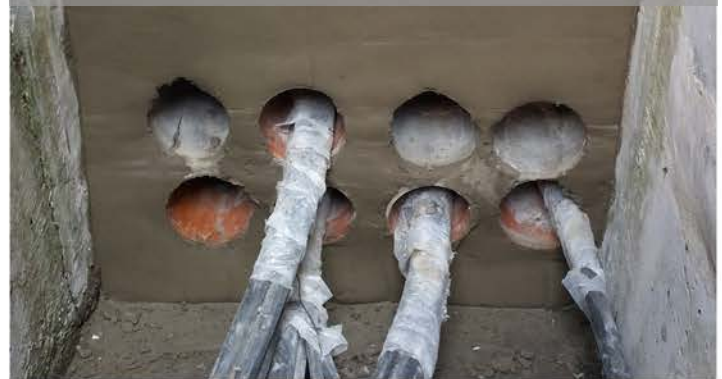
Wall constructed around cables

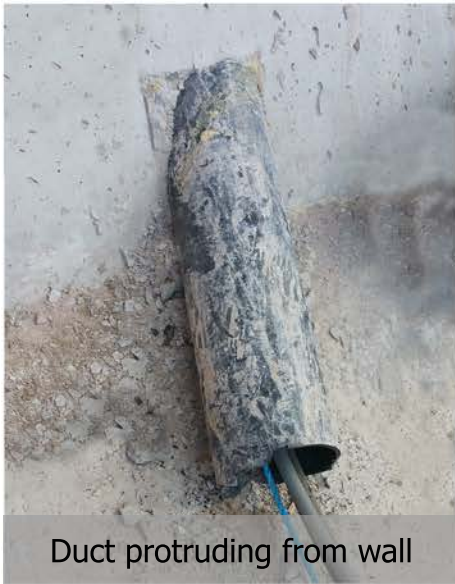
Duct protruding from wall

Several of the ducts also required the existing duct to be cut away to allow an effective seal to be installed; in these instances the duct was carefully cut away using industry approved techniques.

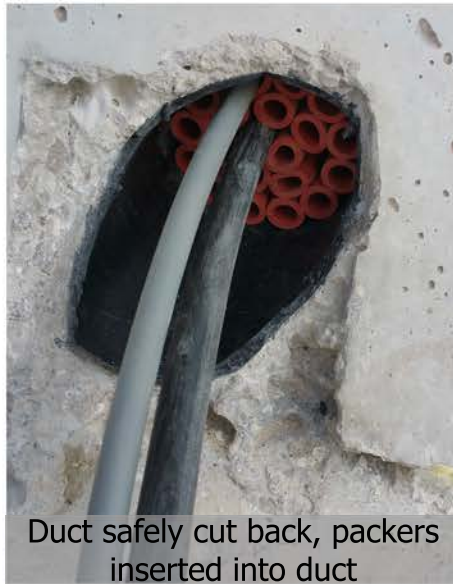
Duct safely cut back, packers inserted into duct

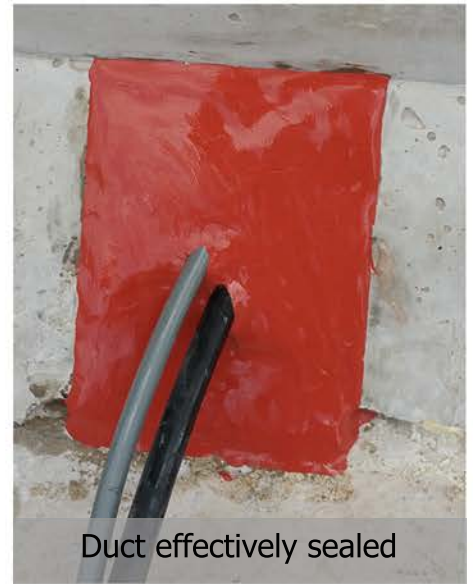
Duct effectively sealed

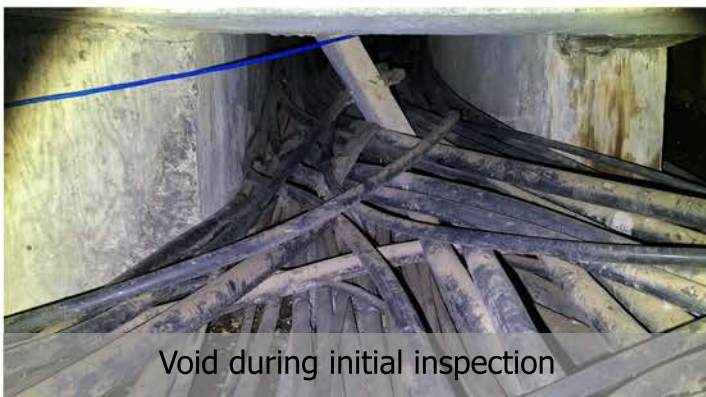
Void during initial inspection

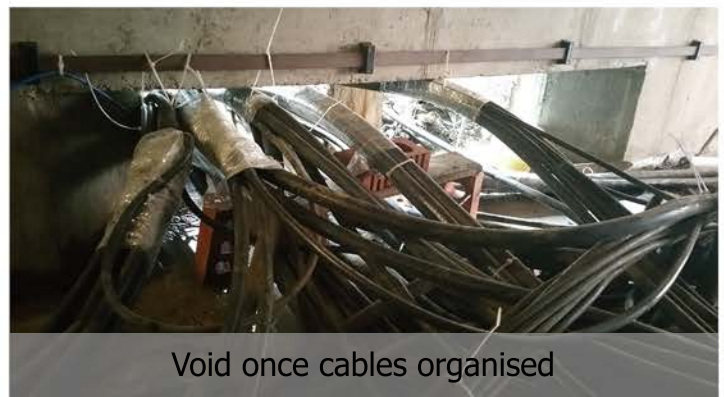
Void once cables organised

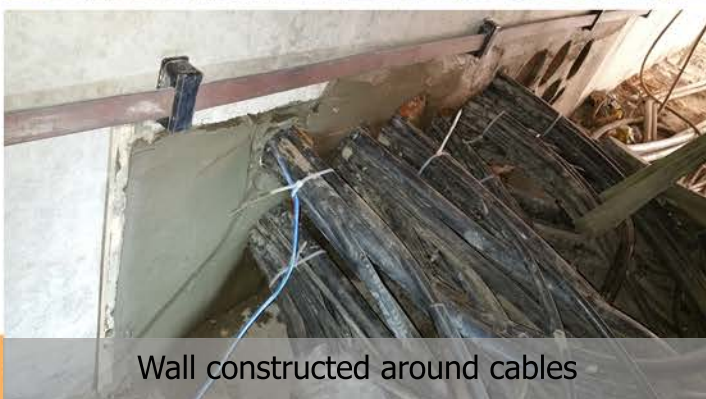
Wall constructed around cables

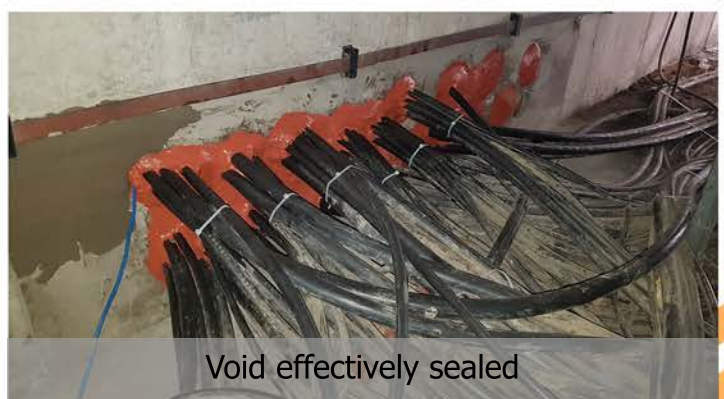
Void effectively sealed
