## HFO Tank Decommissioning Case Study

We were contracted to decommission the iconic "Thomas the tank engine" Heavy Fuel Oil tanks at Singleton Hospital in Swansea.

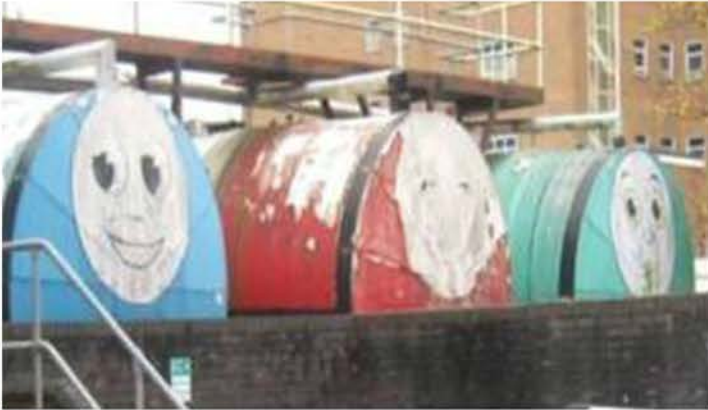
The tanks were painted in the 1990's to look like Thomas, Henry and James, whilst they were overlooked by the children's ward. Despite the fact the overlooking building is no longer a children's ward the tanks were still a favourite with staff and patients at the hospital.

The 45,000 litre tanks had been redundant for several years and contained around 7,000 litres of residual Heavy Fuel Oil inside each tank.

The oil was sampled to establish the sulphur content. As the sulphur was below the recycling threshold the oil could be sent for recycling, leading to a substantial waste and cost saving.

The oil needed to be heated to between 50-70 °C to lower its viscosity to a level where it could be pumped. In two of the tanks the heating coils had been removed meaning temporary heaters had to be installed to heat the HFO to the required temperature.

Once the oil was sufficiently fluid the 3 tanks were emptied by a vacuum tanker and the oil was sent for recycling.

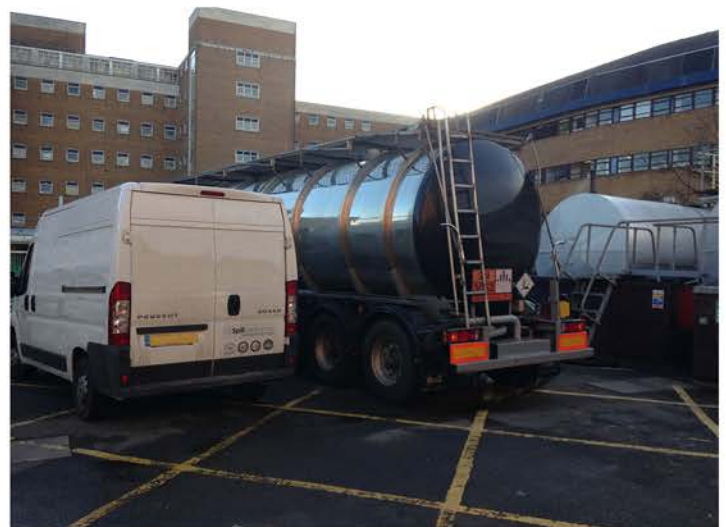
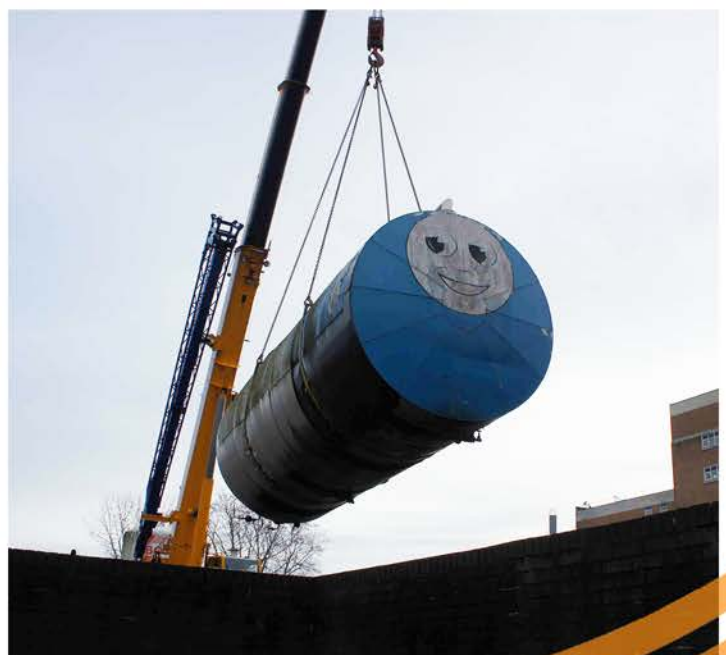
The gantry surrounding the tanks was dismantled allowing access for the crane to lift the tanks out.

In order to reduce the disruption and time-frame the tanks were removed from site in one piece and transferred to a licensed facility to be dismantled and thoroughly decontaminated so that they could be sent for recycling.
