Environmental
Management
Services

Interceptor Service & Repair Case Study

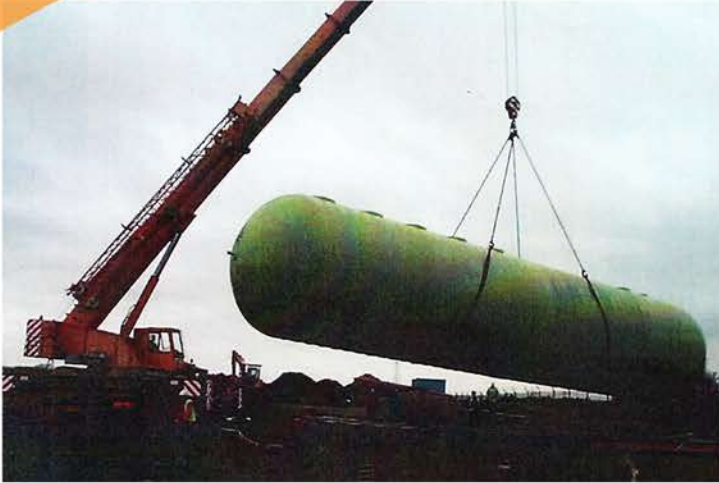
During our initial inspection we discovered that the lack of any maintenance since its installation had resulted in a build-up of 50 cm (approximately 8 tonnes) of silt and 20cm (approximately 5000 litres) of oil.

Our discharge analysis showed that the TPH levels leaving the interceptor were substantially above the 5ppm threshold, discharging directly into an adjacent river.

During the audit we used a forklift to carefully remove the coalescers and inspected them on the surface. We found that of the 5 coalescers 1 had become unattached and was sunk in the chamber; the remaining 4 were heavily saturated in oil and all 5 needed removal and refurbishing.

We recommended a full service and integrity inspection in order to remove the oil and silt, inspect the structural integrity of the interceptor and replace the faulty coalescers.
