**Environmental
Management
Services**

Interceptor Repair Case Study

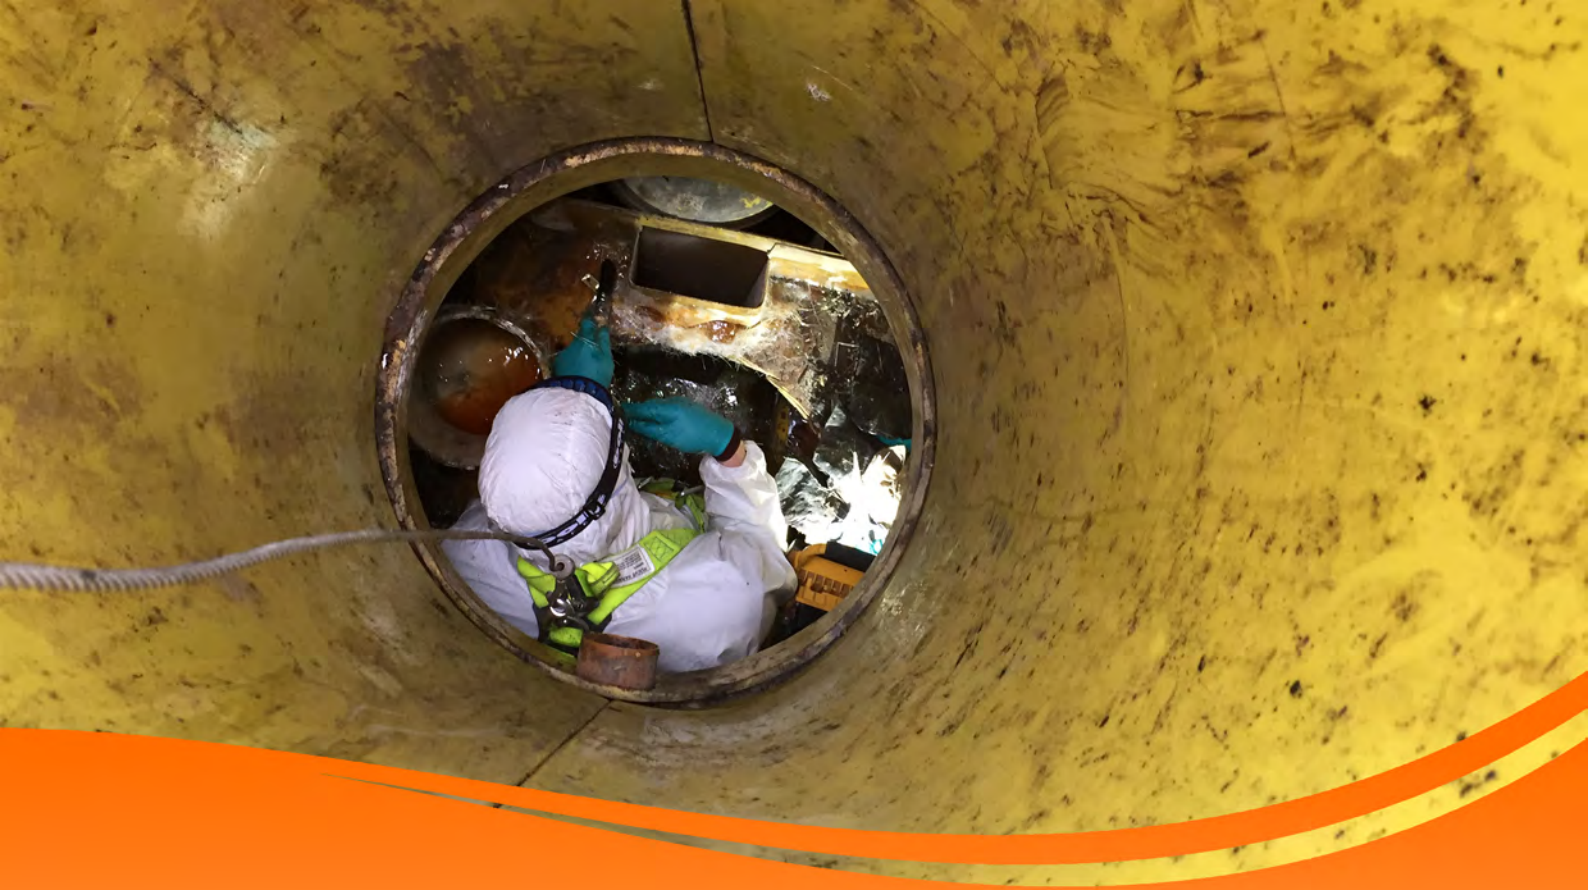
During a CCTV interceptor integrity inspection we found that the baffle wall on a GRP system had broken away from the external walls of the interceptor. We recommended that a repair was made as the interceptor was no longer functioning correctly.

During an interceptor integrity inspection we found that the baffle wall on a GRP interceptor had become delaminated. This had caused the wall to become much weaker which had resulted in it partially dislodging and shifting by approximately 50cm, preventing it from functioning effectively.

We made appropriate provisions to repair the interceptor and made a revisit with specialist staff and equipment. The interceptor was repaired using GRP patch repairs leaving the system fully functional at a fraction of the cost of replacing the interceptor.
