**Environmental  
Management  
Services**

## **Diesel Spill Response & Remediation Case Study**

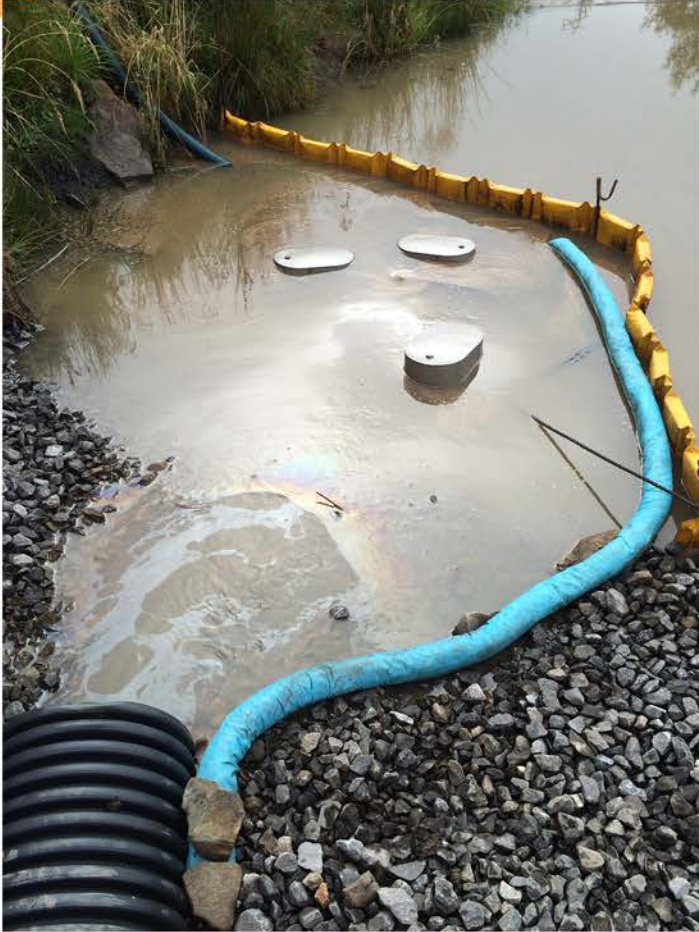
The oil selective booms were regularly maintained to ensure they remained effective at preventing further contaminant migration and promoting oil recovery, however the amount of free oil in the lagoon was of sufficient quantity to necessitate the installation of an oil water separator and skimmer to enhance the recovery process.

Semi-permanent booms were deployed to effectively dam the oil allowing the build up to be skimmed and recovered. The system was enhanced and accelerated by installing a second pump that transferred treated surface water back to the source zone, flushing residual contamination to the control point.
