**Environmental  
Management  
Services**

## **Engineering Laboratory Cleaning Case Study**

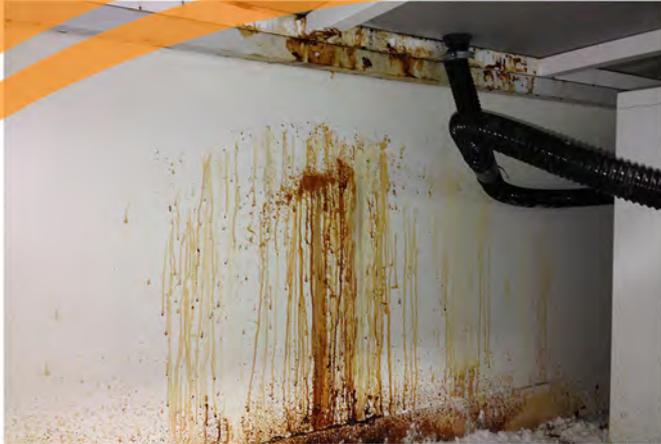
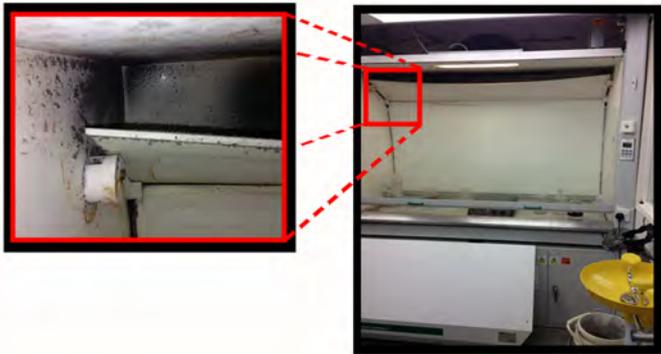
We were approached by a metal coating company who needed an on-site laboratory decontaminated. The fume hood had a faulty extraction unit which had led to a build-up of chemical deposits within the fume hood ducting and the walls and floor of the lab.

As a result a testing methodology was devised to ascertain if any explosive deposits were present. A series of samples were taken from strategic points through the system. The sample analysis showed no perchlorates were present; however as a belt and braces approach all surfaces were thoroughly washed down with copious amounts of water to mitigate risks.

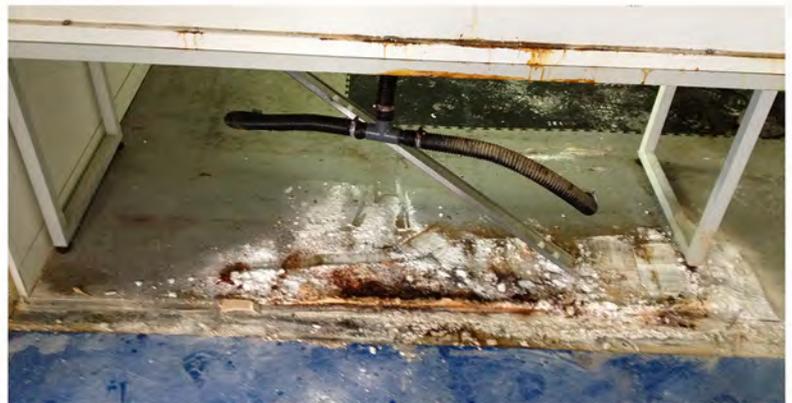
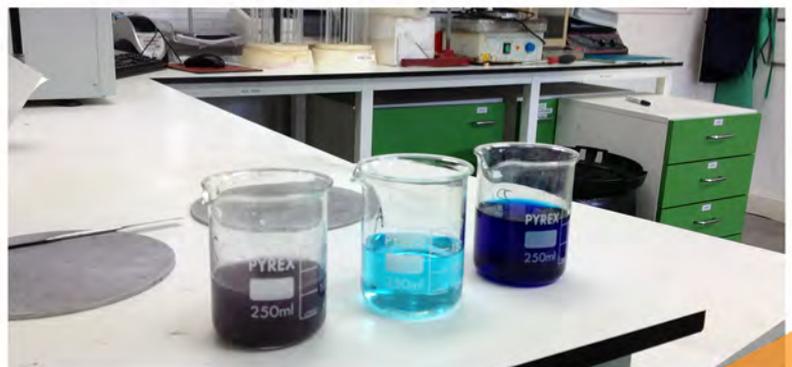
As one of the stud walls was heavily contaminated, the safest and most cost effective solution was to remove and dispose of the wall. This allowed us access to the rear of the fume hood, which was fully decontaminated to allow the fume hood to be re-used.

Before any disassembly of the 20m length of 12" ductwork we performed a series of water flushes. This wash water was tested to further ensure there was no Perchlorate deposits present prior to breaking the seal at the back of the hood to the vent.

All wastes arising from the decontamination works were classified allowing the waste to be disposed of in line with regulations in the most cost effective manner. Swab samples were taken to validate that the decontamination had been a success and that no hazardous residues remained.
