Bioremediation Case Study

Domestic Kerosene Spill

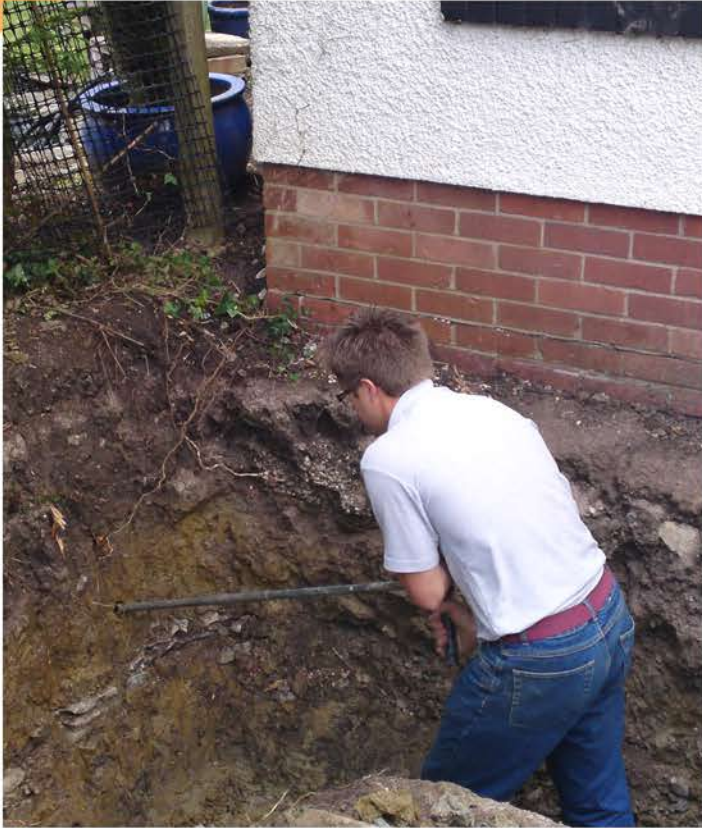
The first task was to identify the level of contamination. Hand excavations were dug at the source zone removing the initial contamination.

The plume was investigated using olfactory and VOC readings from a Photo Ionisation Detection Monitor. This identified that the plume had migrated underneath the footings of the property.

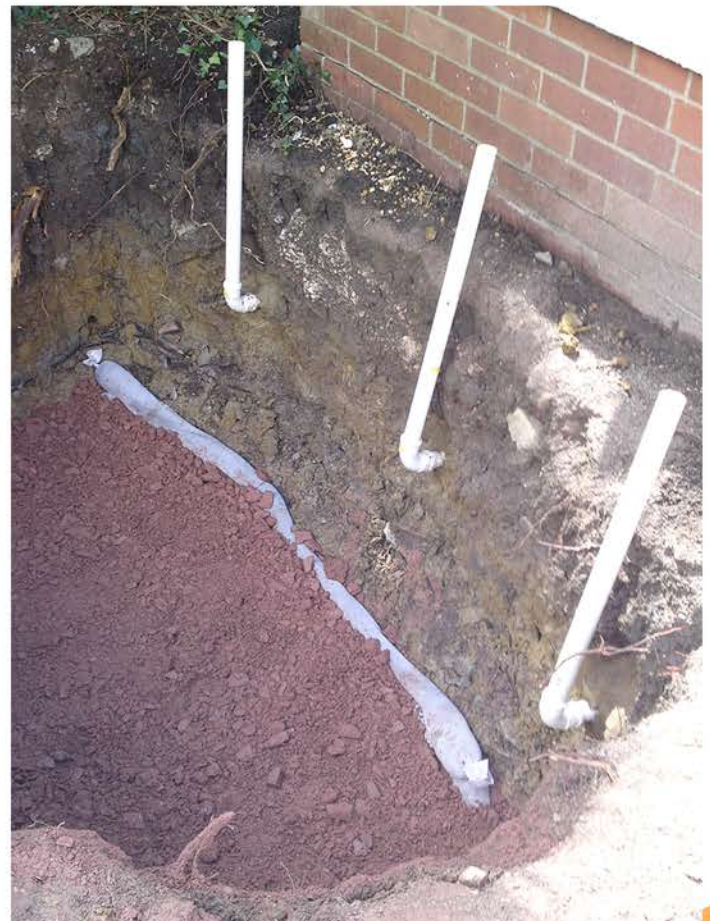
Three injection wells were installed laterally beneath the footings of the property to the boundary of the contamination plume.

Oil degrading bacteria, nutrients (phosphates, nitrates and potassium) and slow oxygen releasing compounds were then discharged to initiate and support the bioremediation.

Barrier technology and carbon filters were installed to prevent any mobilised contamination entering the initial excavation.

The excavation was reinstated and the property was returned to its original condition.
