## Environmental Management Services

## 30,000 litre Glucose Spill Case Study

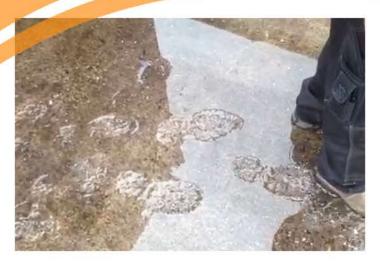
We were called to a spill following the rupturing of pipework connected to a glucose tank. The tank was not bunded and the spill covered the yard and filled the drains.

The spill occurred out of hours and so went undiscovered allowing the entire tanks contents to spill. Production had to be ceased until the yard was clean enough for a delivery vehicle to refill the tank meaning the clean up had to be conducted within 18 hours.

The drain run downstream was inspected to ensure no glucose had been discharged from the separator and the outlet from the drain run was plugged using an inflatable drain blocker to ensure no glucose could migrate off site.

Due to the viscosity of the glucose the only viable way to remove it was by heating and agitating it using a heated jet washer and use a vacuum tanker to pump it away. We arranged for a tanker to attend site and for empty IBCs to be made available to transfer the glucose into, this drastically reduced downtime when the tanker reached capacity.

Our spill response team worked through the night to clear a path for the delivery vehicle the following morning.

Once the delivery was successfully made we completed the spill clean up by hot jet washing the remaining residues and collecting the wash water using the tanker.

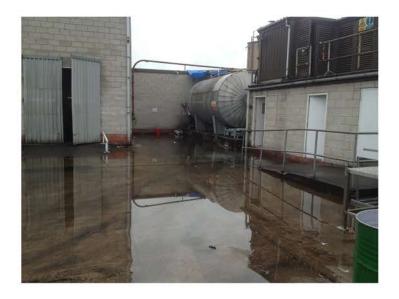
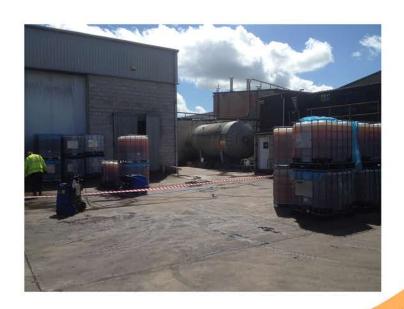
The spill had covered their yard and filled their drains. The glucose had been heated in the tank to increase fluidity, however once it discarged and cooled it became extremely viscous slowing its progression through the drainage and subsequently being contained by a separator.
